Maintainer

Issue 4/2004

Static Electricity: An Ever-Present Danger!

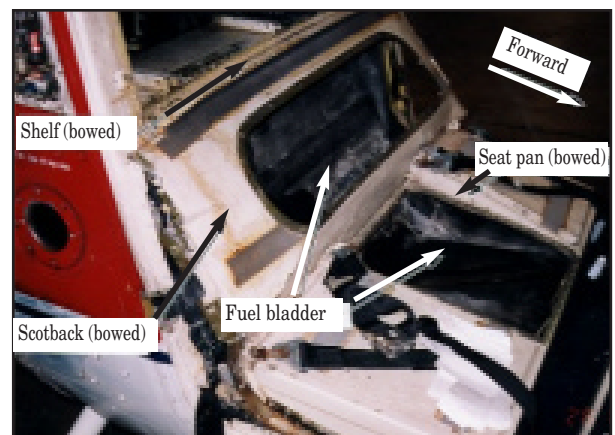
Augusta Bell 206B—Damage to fuel bladder and cabin structure following in-flight explosion.

The helicopter sustained damage to the structure surrounding the fuel bladder. There was upward deformation of the shelf structure and heavy deformation of the rear bench seat and seat back. Structural damage was consistent with an over-pressure of the bladder. The vent line was examined and was free of obstruction. There were three splits on the right-hand side of the bladder, close to the fuel hose and in the same lateral plane as the aft boost pump. There was evidence of combustion in the tank; blistering about 25 percent of the interior surface near the three splits in the bladder. In the

area where the two fuel hoses crossed and touched one another, there were distinct signs of heating and abrasion—this area had become stiff, and broken strands were noted. The hoses were made of rubber/polymer and were reinforced with steel braids on the outside.

Laboratory analysis confirmed that this localized heating damage at the area of contact suggested that this was possibly the source of the flame front. The more extensive damage to the purge line hose indicated that there had been a prolonged smouldering, but it was not possible to ascertain whether this was the cause or a result of the explosion.

For Bell 206B operators, it would be prudent to ensure that fuel lines are properly tested for electrical bonding, that they are secured by "P" clips when necessary to prevent abrasion and that the fuel pump umbrella check valves are secured and perform as designed. When unchecked, static electricity can have a devastating effect on an aircraft.

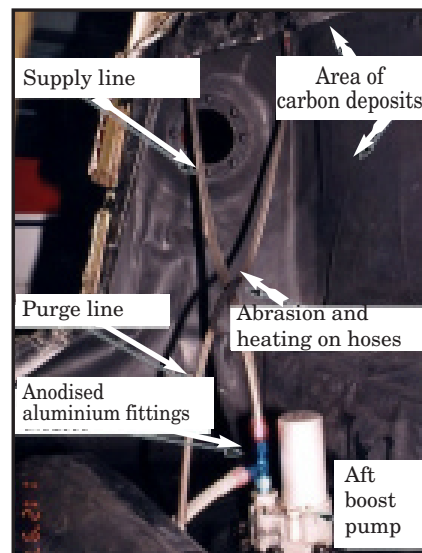
Augusta Bell 206B—Fuel bladder cut-out showing fuel pump and fuel line configuration at the time of the accident.

Electrical bonding of the aircraft was checked and found satisfactory at first. A continuity check of the hose and fitting of the two fuel lines revealed that one of the lines acted as an insulator. The purge line had the conventional grey steel nozzle and nipple fittings at the ends, and had good electrical continuity, but the blue and red anodized fittings of the fuel supply line acted as insulators. This prevented continuity between the hose and its connection to the boost pumps and the outlet to the engine. The hose manufacturer confirmed that it was an Aeroquip 601-type hose that met Military Specification MIL-H-83797. In the smaller diameter lines, such as for the purge line, the fittings are steel and provide good electrical continuity, but in the larger diameter configuration, the end fittings are of anodized aluminium, and they are non-conductive until the finish is worn. Military Specification MIL-H-83797 does not contain specific provisions regarding electrical conductivity along the hose or across the end fittings. The manufacturer states that it can be provided when the customer asks for it and this is done for particular applications. More recent designs of hoses and fittings include specific provisions for this conductivity factor on this type of helicopter and most other aircraft designs.

The UK's Aircraft Accident Investigation Branch (AAIB) discussed the topic of conductivity with other aircraft manufacturers and all agreed that the fuel hoses within the tanks should be electrically bonded, and that the majority of designs today apply this principle either by electrical continuity within the hose assembly or by adding extra bonding leads and clamps. The two fuel lines had been manufactured in-house under the operator's maintenance manual approval using Aeroquip materials.
